Cody, Wyoming

Culvert Reline with Weholite

Culvert Rehabilitation
Cody, Wyoming

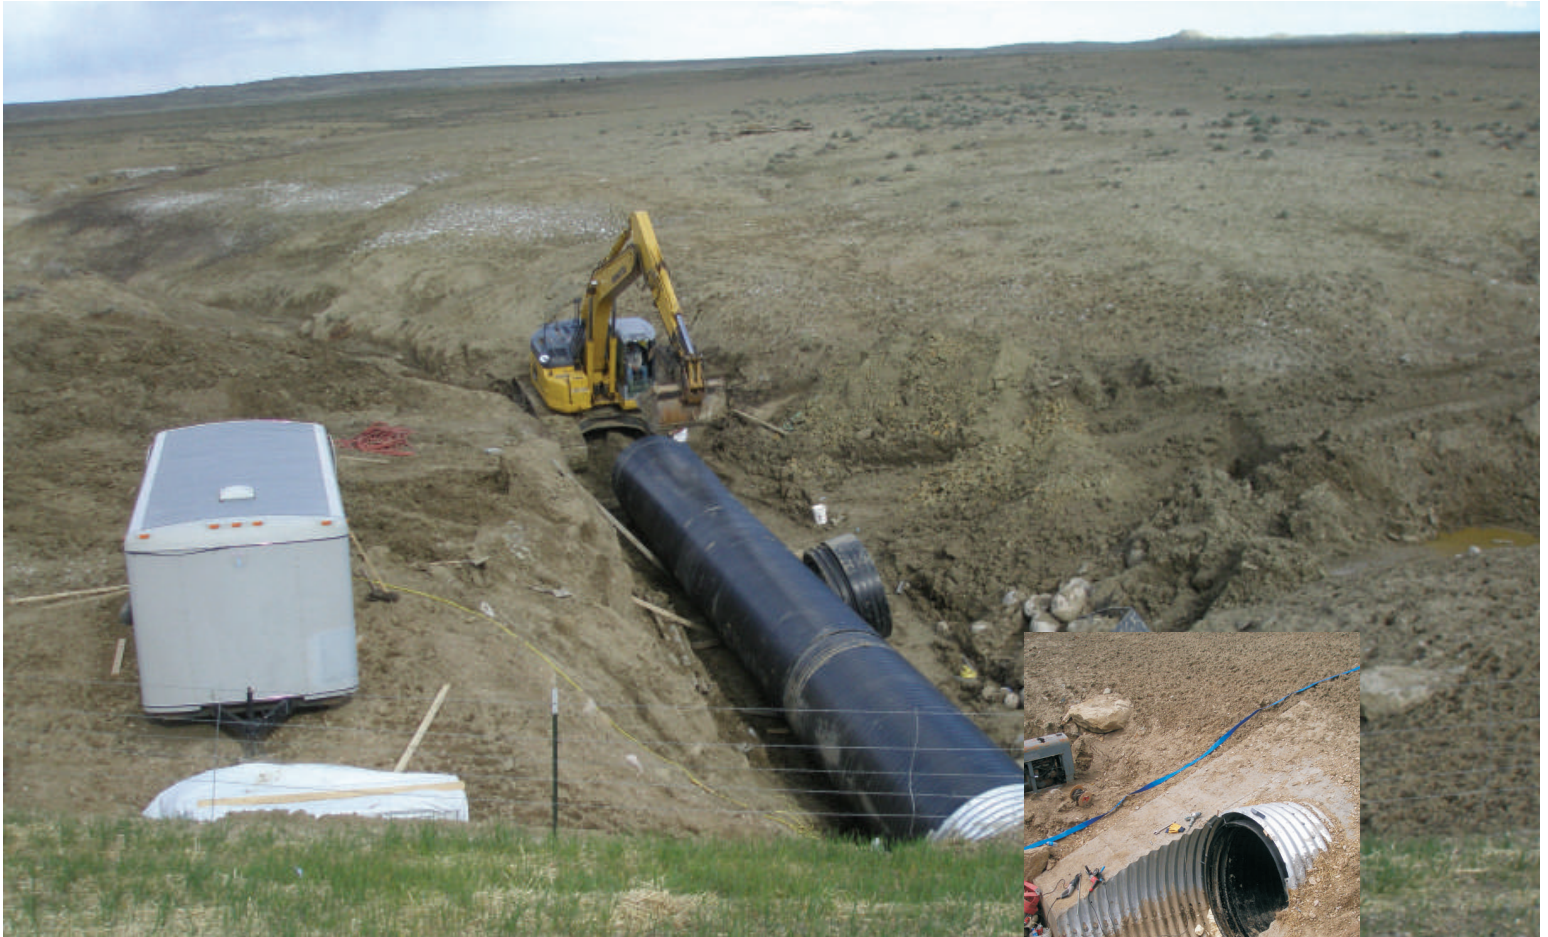
The last length of Weholite is successfully pushed into place.

Weholite was ultimately chosen to slipline the damaged culvert. The 45' lengths of 72" Weholite were inserted into the existing pipe. The threaded ends of the Weholite allowed the contractor to easily join the pipe. The project was completed in just a couple of days with no traffic interruption on this busy highway.
