Algonquin Park, Ontario

Culvert Reline

Rehabilitation with Weholite is becoming the solution of choice when it comes to repairing the Ontario Ministry of Transportation's failing culverts.

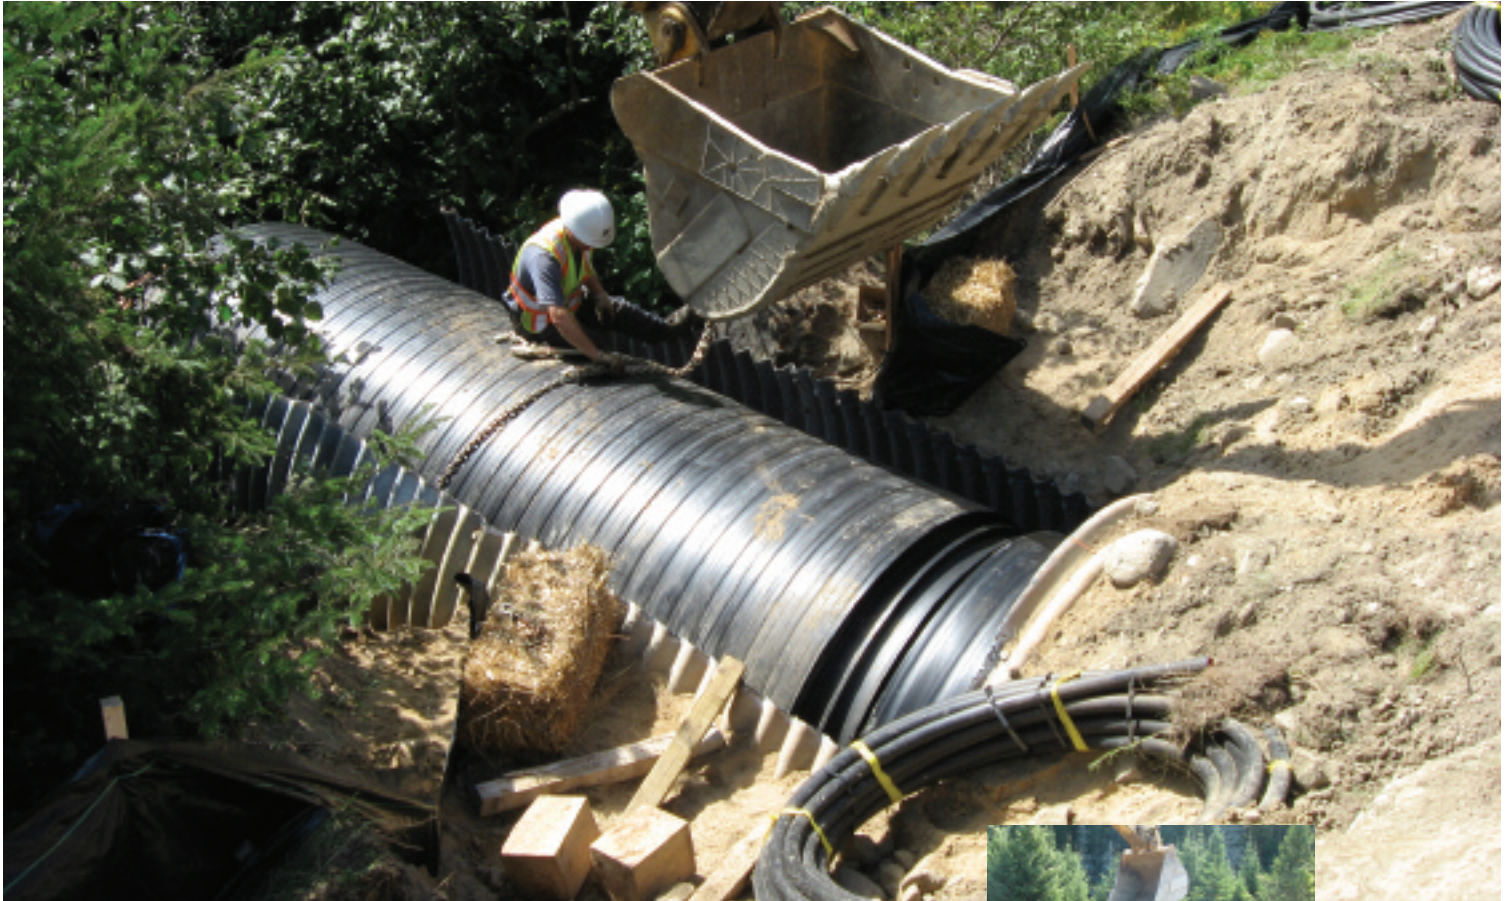
In the fall of 2008, a large diameter metal culvert was rehabilitated with minimal interruption to local residents and visitors to the area. The project site was along Hwy 60, a provincially maintained west-east highway and the major access corridor for Algonquin Provincial Park, which covers approximately 7,630 square kilometers. This newly rehabilitated culvert is located within the park, which is a national historic site and used extensively for wildlife research. A requirement of this project was that all work had to be completed within the roadway allowance so that the integrity of the surrounding woods would remain undisturbed. This posed some challenges to the contractor, but was made possible with the standard 16.5' laying lengths of Weholite pipe. The unique laying length and "Thread-loc" joint allowed the contractor to assemble and insert the Weholite with little difficulty. When the pipe was completely installed and secured inside the distressed culvert, the annular space was filled with grout to complete the project.

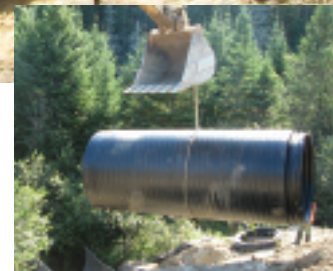
78"ID Weholite pipe is lowered into place.
