Berthoud Pass, Colorado

Culvert Reline with Weholite

Project:
US 40 Culvert Reline
Berthoud Pass, Colorado

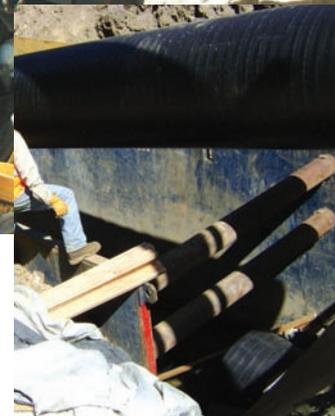
Maneuvering Weholite in tight quarters.

Lightweight Weholite was manufactured in custom short lengths which enabled the contractor to easily negotiate the close working conditions. The contractor was able to maneuver the 45' lengths into position using only a small track hoe. All the joints were extrusion welded at the site and the completed project took only a couple of days. Best of all, there was no disruption to traffic during the entire project.
