# Cody, Wyoming

## Culvert Reline with Weholite

**Project:**  
Culvert Rehabilitation  
Cody, Wyoming

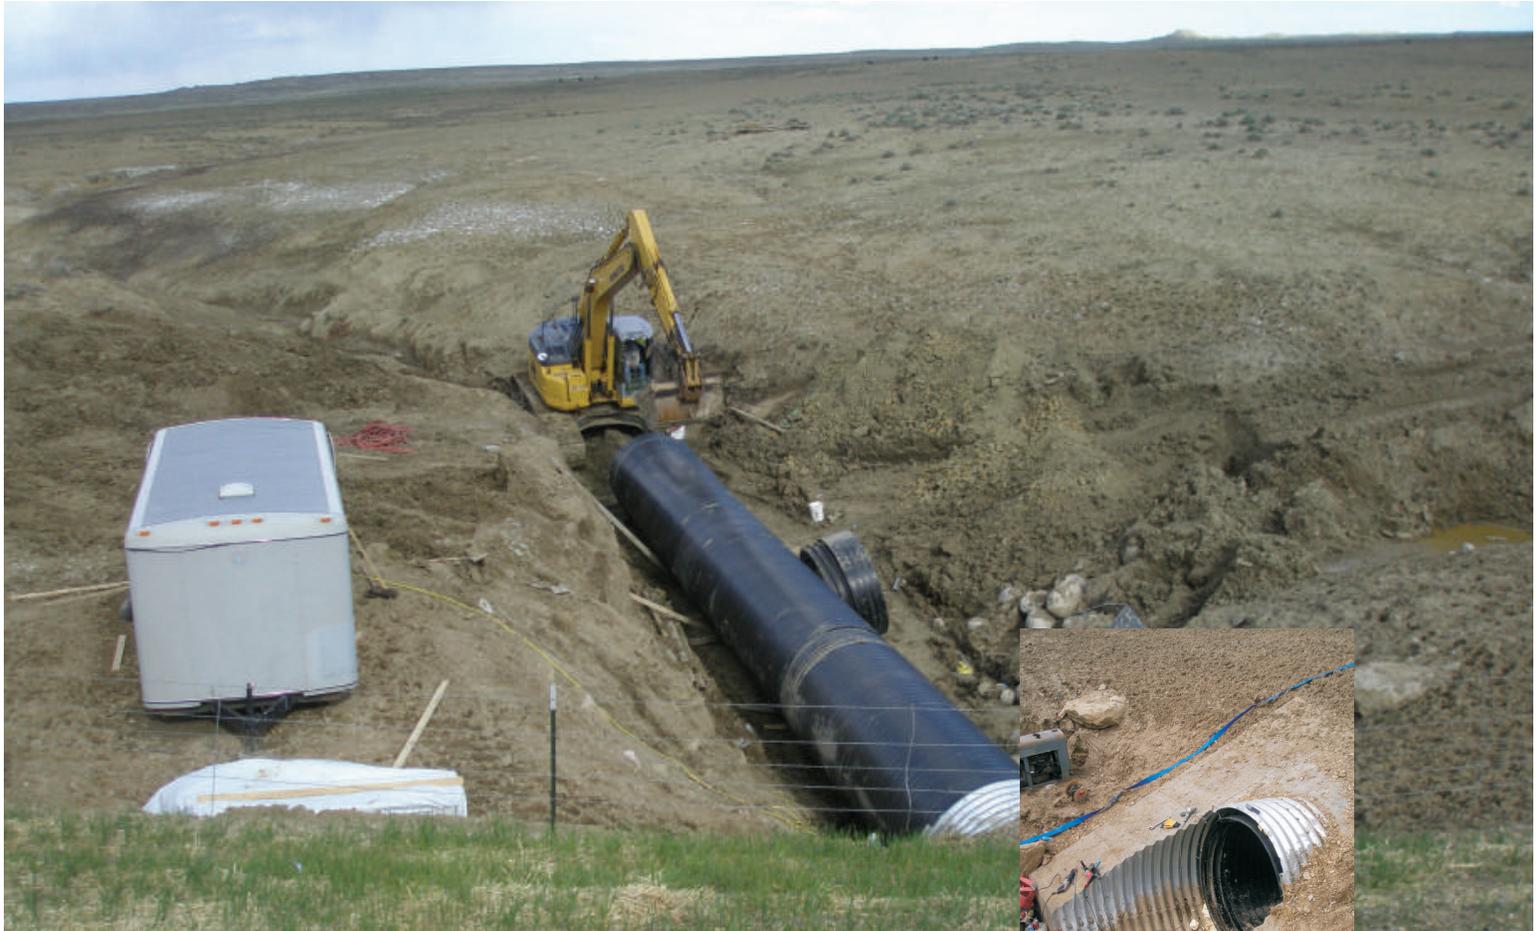
The existing culvert consisted of 180' of 96" corrugated metal pipe showing severe damage. The inlet and outlet ends had already been replaced with new multi-plate steel, but the cost of replacing the remainder of the culvert with that material would have been enormous. This led WYDOT to seek out another solution.

Weholite was ultimately chosen to slipline the damaged culvert. The 45' lengths of 72" Weholite were inserted into the existing pipe. The threaded ends of the Weholite allowed the contractor to easily join the pipe. The project was completed in just a couple of days with no traffic interruption on this busy highway.

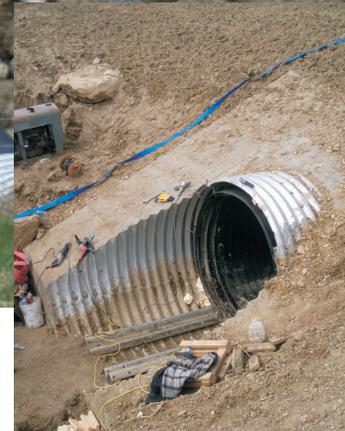
*The last length of Weholite is successfully pushed into place.*
